## EUROPEAN PATENT APPLICATION

(54) **Method for repairing an apertured gas turbine component**

[0001] The present invention is directed to repairs of a coated gas turbine component, and more particularly, to repairs of defects in an air-cooled gas turbine vane having diffusion cooling holes where the vane is coated with a thermal barrier coating (TBC) system.

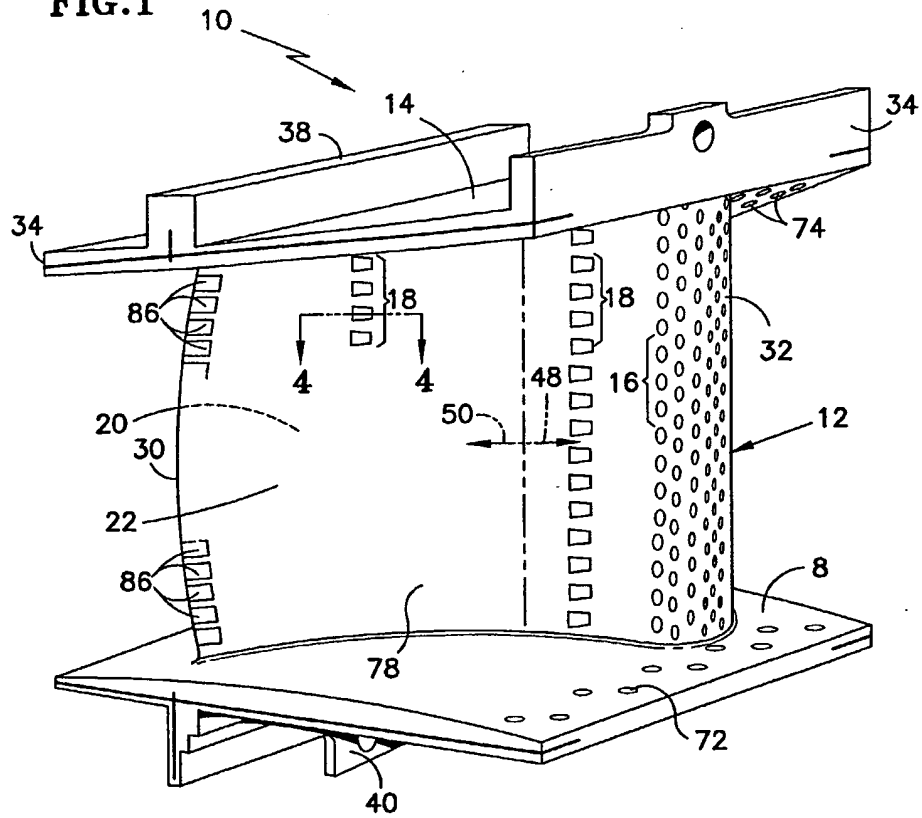
FIG.1

Fig. 1 is a perspective view of a typical gas turbine engine high pressure turbine vane;

[0025] Referring to Fig. 1, a high pressure turbine vane (article) 10 is shown. Referring also to Figs. 2 and 3, a top view and a bottom view are respectively shown for the vane 10 of Fig. 1. The vane 10 comprises an airfoil section (airfoil) 12 having at least one internal cavity 24 (Fig. 2), the internal cavity 24 having an internal surface 26 (Fig. 2). The airfoil section 12 has a convex surface 20 and a concave surface 22. The convex and concave surfaces 20, 22, respectively, are bounded by a trailing edge 30 and a leading edge 32 and together form an exterior surface 78 of the airfoil. The exterior surface 78 is exposed to the hot gas path. The trailing edge 30 of the airfoil 12 includes cooling slots 86. Also, the airfoil section 12 is bounded by an inner diameter platform (platform) 8 and an outer diameter platform (platform) 14. The inner and outer diameter platforms 8, 14 create the gas path annulus and include cooling holes 72, 74, respectively. The outer diameter platform 14 includes opposing flanges 34, at least one cover 36 (Fig. 2), preferably two, and a rail 38. The inner diameter platform 8 includes a rail 40 and a cover 42 (Fig. 3), preferably two.

[0027] The vane 10 lies in the hot gas path and the vane 10 is air-cooled by flowing cooling air, typically from the compressor discharge, into the internal cavities 24. Cooling air enters the internal cavities 24 through corresponding openings in the platforms 8, 14. This air cools the internal surface 26 of the airfoil 12 by convection or internal baffle impingement and cools the convex and concave surfaces 20, 22, respectively, of the airfoil 12 by film cooling. The air is directed from the internal cavities 24 and outward across the vane 10 by a plurality of cooling holes, preferably cylindrical cooling holes 16 and diffusion cooling holes (diffusion holes) 18, to help it withstand the high temperatures to which it is exposed. The cooling air is also directed across the platforms 8, 14 upon exiting the respective cooling holes 72, 74. The trailing edge 30 is cooled by air exiting through the slots 86.

[0028] Although Fig. 1 shows the plurality of cooling holes 16, 18 located on the concave surface 22, it is readily understood by those skilled in the art that the plurality of cooling holes 16, 18 are formed on both the convex and concave surfaces 20, 22, respectively.

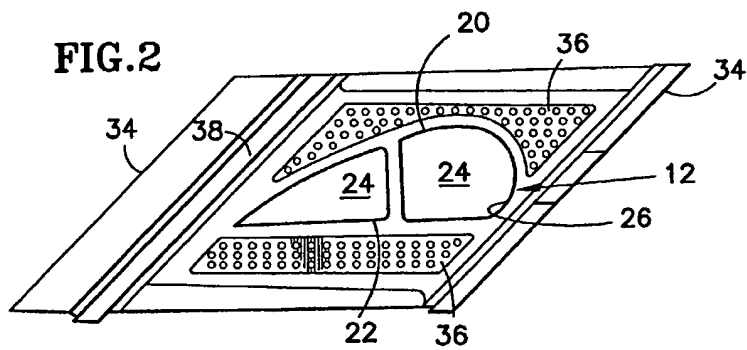
FIG.2

Fig. 2 is a top view of the vane of Fig. 1;

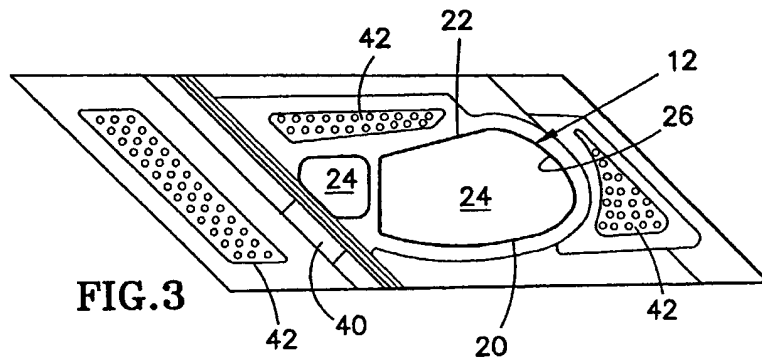
FIG.3

Fig. 3 is a bottom view of the vane of Fig. 1;

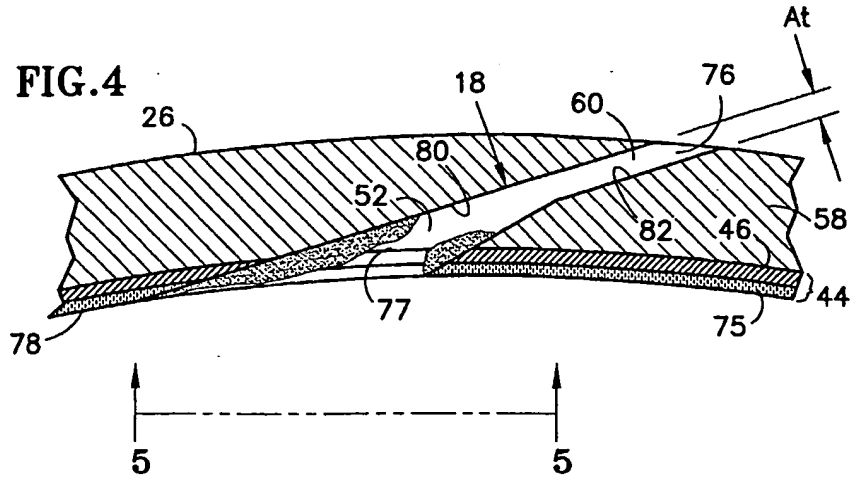
FIG.4

Fig. 4 is an enlarged cross-sectional view taken essentially in the direction 4-4 of Fig. 1 and illustrating the vane substrate, an existing protective coating applied to the substrate and a typical diffusion cooling hole extending through the substrate and the coating;

[0029] Referring to Fig. 4, a cross-sectional view of the wall thickness of the airfoil 12, and in particular the diffusion hole 18, is shown taken along the line 4-4 of

[0030] To further protect the vane 10 (Fig. 1) from high temperatures, the airfoil 12 and the platforms 8, 14 are coated with a protective surface coating, preferably a thermal barrier coating (TBC) system. The thermal barrier coating system 44 comprises a metallic bond coat 46 disposed over a substrate 58 of the vane 10 (Fig. 1), and a ceramic top coat 75 on top of the bond coat 46.

[0031] Referring now to Figs. 1 and 4, it is noted that the vane 10 has a plurality of diffusion holes 18 which may have various geometries and predetermined air flow characteristics based on location within the vane 10. The representative diffusion hole 18, shown in Fig. 4, has a metering passage 60 in fluid communication with a diffusion passage (mouth) 52, each having a predetermined geometry. The metering passage 60 has an inlet 76 with a predetermined throat area, shown as  $A_t$ , where the throat area  $A_t$  provides a predetermined air flow requirement. Thus, the inlet 76 regulates cooling air flow into the diffusion holes 18 from the internal cavities 24. The diffusion passage 52 is axially diverging, nonregulatory and extends from the inlet 76 to an outlet 77 at the exterior surface 78 of the vane 10. The diffusion passage 52 facilitates the film cooling of the exterior surface 78 of the airfoil 12 as the cooling air exits from the diffusion passage 52 of the diffusion hole 18. The diffusion passage 52 also includes an inner shaped portion (inner diffuser portion) 80 while the metering passage 60 includes an inner metering portion 82.

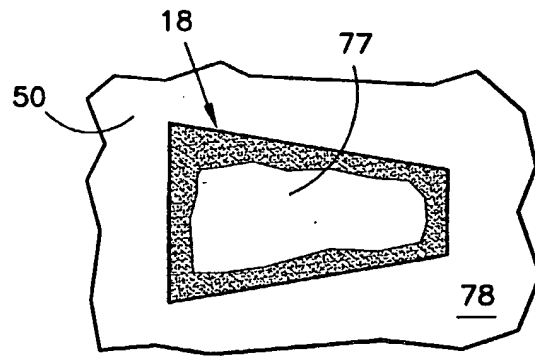
FIG.5

Fig. 5 is a view taken essentially in the direction 5-5 of Fig. 4 showing the diffusion hole prior to the repair of the present invention;

Fig. 1. Fig. 5 shows a view taken essentially in the direction 5-5 of Fig. 4 showing the diffusion hole 18 prior to the repair of the present invention.

[0048] Referring now to Figs. 1, 4 and 5, diffusion holes 18 located in region 50 may require reworking. The application of the nonoriginal metallic bond coat 46 to the entire surface 78 of the vane 10 may result in a quantity of excess bond coating accumulating in the diffusion passage 52 of the diffusion holes 18 thus reducing the area through which the cooling air passes. Since this "coatdown" phenomena, as shown in Figs. 4 and 5, affects most, if not all of the diffusion holes 18 in region 50, the effectiveness of the cooling medium is diminished and the vane's durability is compromised. The coatdown phenomenon is normally not a problem during the manufacture of original equipment vanes since the protective coatings, and in particular, the metallic bond coat, are usually applied prior to installation of the cooling holes.

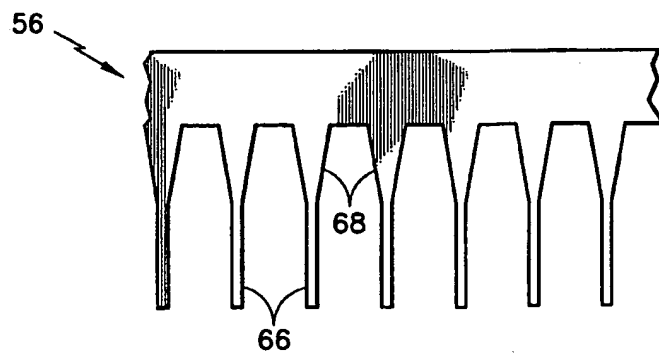
FIG.6

Fig. 6 is a side view of an electrode suitable for use with the repair method of the present invention; and

[0051] Referring to Figs. 6 and 7, electrodes 56, 62 suitable for insertion into an electric discharge machining device are shown. Referring to Figs. 1, 4, 5 and 6, the remanufacture and repair of the diffusion holes 18 in local regions 48, 50 of vane 10 using electrodes 56, 62, respectively, will now be described.

[0052] The electrode 56 includes a metering portion 66 and a diffuser portion 68. The electrode 62 includes a diffuser portion 70. It is noted that the geometry of the individual electrodes 56, 62, specifically the respective portions 66, 68, 70, are preselected to correspond to the required shape of the corresponding diffusion hole 18 to which it is used. In particular, the electrode 56 is chosen to restore the inner diffuser portion 80 and inner me-

[0054] In local region 48, the diffusion hole 18 is now remanufactured using the electrode 56. Since the repair material filled the diffusion hole 18, both the metering portion 66 and diffuser portion 68 of the electrode 56 are required to effect the remanufacture. The diffuser portion 68 of the electrode 56 corresponds in shape to the diffuser passage 52, and more specifically, the inner diffuser portion 80, of the diffusion hole 18. While, the metering portion 66 of the electrode 56 corresponds to the metering passage 60, and more specifically, the inner metering portion 82 of the diffusion hole 18.

[0055] However, in local region 50, the diffusion holes 18 may be partially or fully clogged, as described earlier, and therefore will need to be reworked to restore the cooling effectiveness of the diffusion hole 18 as well as vane durability. This is accomplished by using the electrode 62 to remove the excessive bond coat material. The electrode 62 may be easily formed by removing a metering portion from an electrode that has a diffuser portion corresponding in shape to the diffuser passage 52, and more specifically, the inner diffuser portion 80, of the diffusion hole 18. This can be accomplished by using a cutting means, for example scissors, to remove the metering portion.
